NASA Technical Paper 2711

Shot Peening for Ti-6Al-4V Alloy Compressor Blades

Gerald A. Carek

Lewis Research Center Cleveland, Ohio

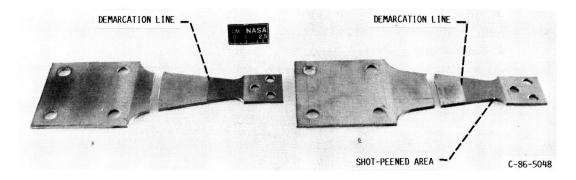
Figure 6.—Typical failed fatigue specimens.

All test specimens in the first group (masked specimens) failed in the area that was not shot peened, well away from the demarcation line. Two typical failures can be seen in figure 6. Therefore it was determined that the demarcation line is not a preferential site for crack initiation. The cracking of the blades in the Lewis multistage compressor can now be attributed to high alternating tensile stress levels only. The cracks in these blades were located on the airfoil near the root fillet, which is between the airfoil and the platform. This is the location at which the bending tensile stress on the airfoil is highest. Since the shot-peened area was limited to the platform and fillet, the airfoil did not have the fatigue advantage that results from shot peening. It is estimated that extending the shot-peened area to about 20 percent of the airfoil

span could extend the fatigue life by a factor of 3 or more. Aerodynamic losses can be minimized by lightly polishing the shot-peened area of the airfoil.
